STUDY OF STRESS-CORROSION CRACKING
OF ALUMINUM ALLOYS

Final Report

May 1967

Rocketdyne
A Division of North American Aviation, Inc.
Canoga Park, California

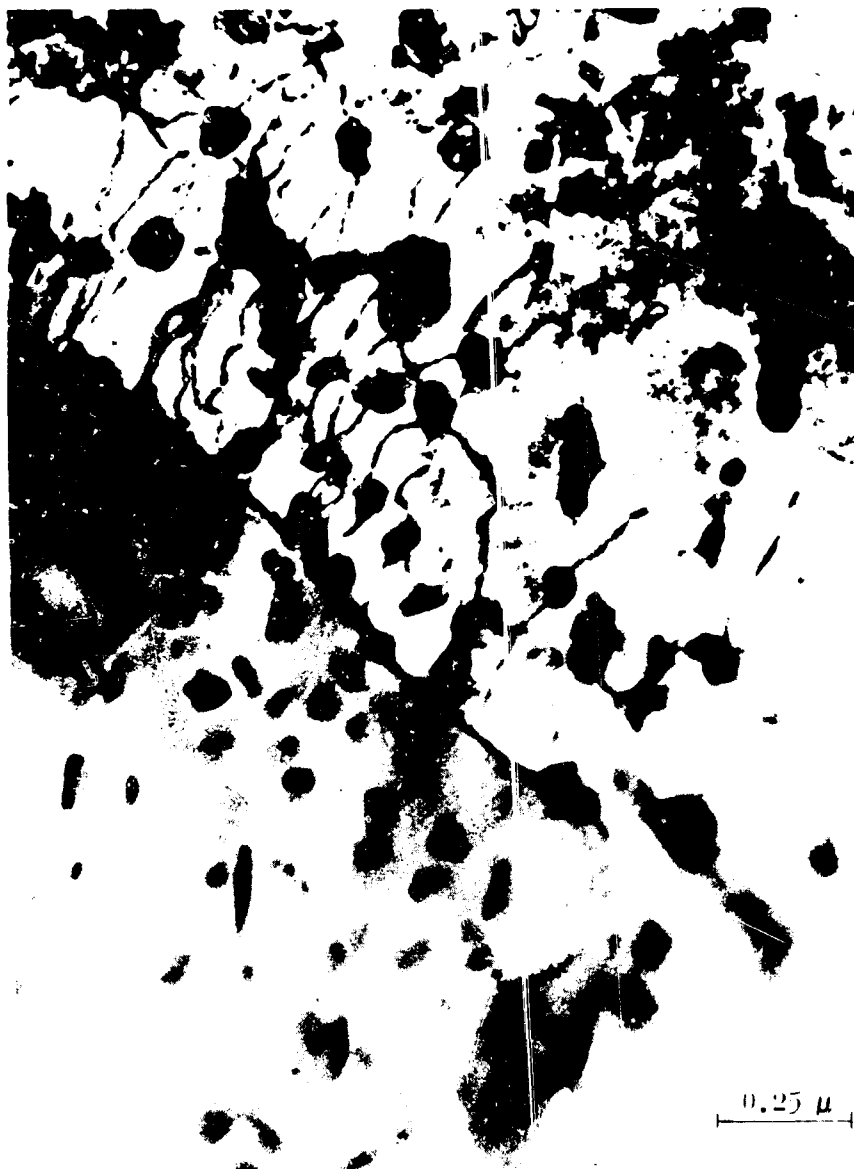
Figure 1. Transmission Electron Micrograph of 7075-T6 Specimen Showing Close Association of Dislocations and Grain Boundary Precipitates.

Thin film microscopy disclosed no differences between the grain boundaries in -T6 and -T73 specimens, other than the close association of dislocations with precipitates in -T6 specimens (Fig. 1) which was not in evidence in -T73 specimens (Ref. 1). The composition of the grain boundary precipitates in the two tempers was shown to be the same, viz., $MgZn_2$, through the use of selected area diffraction and dark field techniques, and the precipitate morphologies and sizes were also similar. A corrosion study of unstressed -T6 and -T73 specimens in an aqueous 3-12 percent NaCl solution indicated that the main corrosion process is identical in the two conditions. This process consists of the dissolution of the grain boundary precipitates,⁽²⁾ which thus act as anodes.

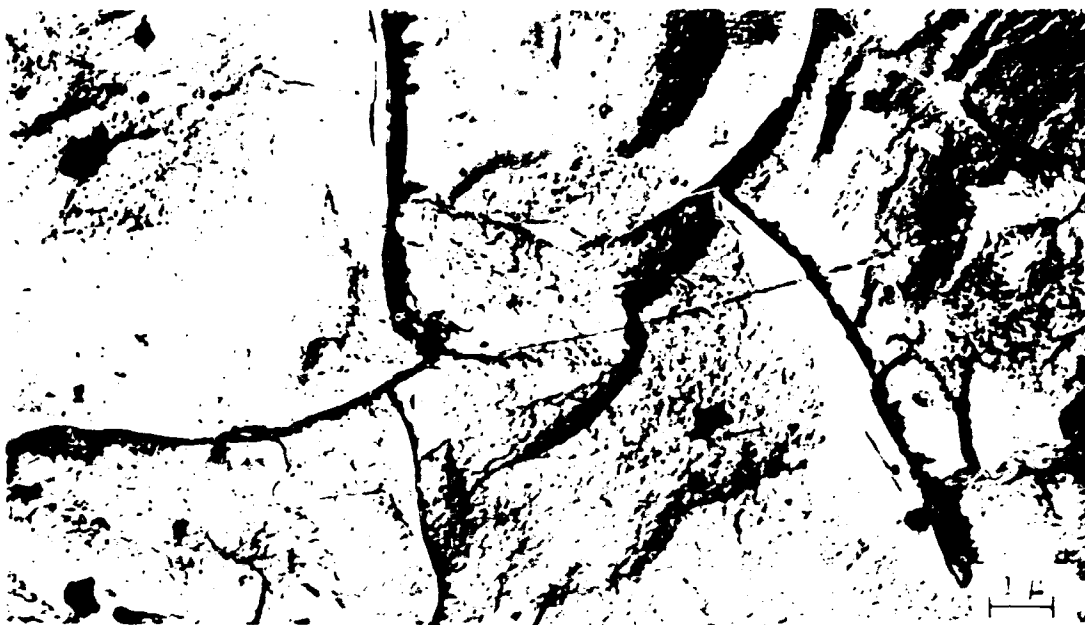
The fractographs showed that the fracture surfaces in the dark areas were almost entirely intergranular in nature, while those in the light areas were predominantly transgranular (Fig. 12). Quite severe corrosion had taken place in the dark areas, and the products of the corrosion reaction were considerably more abundant in these areas than in the light areas.

Figure 12a. Intergranular Fracture Typical of Stress-Corrosion Phase of Failure in a Notched 7075-T73 Specimen. (Note corrosion product in rough-textured area.)

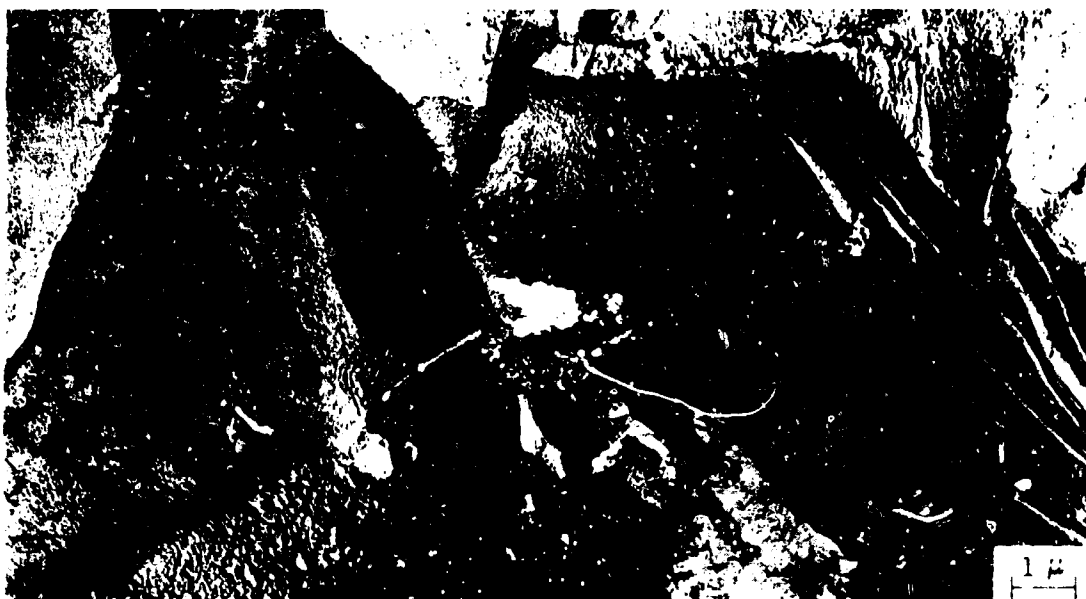
Figure 13. Fractograph of Stress-Corroded Area in a Notched 7075-T73 Specimen Showing Cleavage Steps at A. (Cleavage steps are indicative of brittle fracture.)

Although such signs of brittle fracture as cleavage steps (Fig. 13) were observed in the dark areas but not in the light, there were still numerous signs of ductility in the dark areas. A dimpled structure was frequently observed, as shown in Fig. 14. Dimples were also observed frequently in the light areas (Fig. 12b).

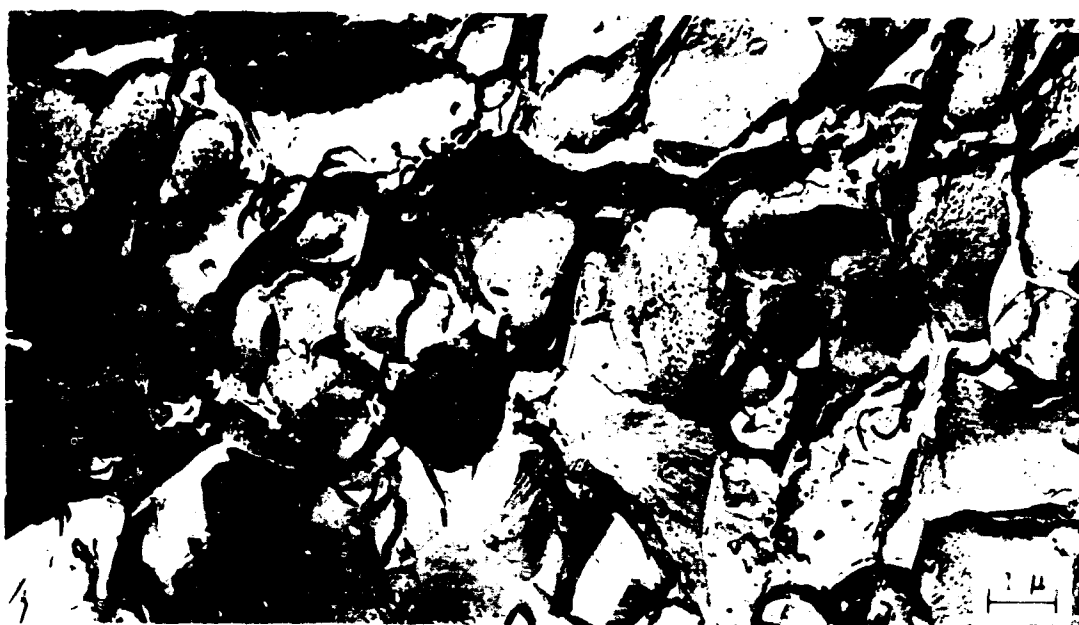
Figure 17. Intergranular Fracture in an Unnotched
7075-T6 Tensile Specimen

The fractographs obtained from the tested tensile specimens revealed approximately what was expected: a predominantly dimpled, transgranular appearance, with the extent of dimpling being smaller in the notched than in the unnotched specimens (Fig. 15 and 16). Occasionally, the fracture was observed to be intergranular (Fig. 15b, 16b, and 17).
